Re: Preliminary findings pertaining to forensic engineering investigation of damage and distress to 15 story condominium building; Insured: Mustang Towers; Claim No.: 1027766; Policy No.: 65884208; Property Address: 6109 Highway 361 in Port Aransas, Texas; Date of Loss: 8/25/2017; Our File No.: 18-207

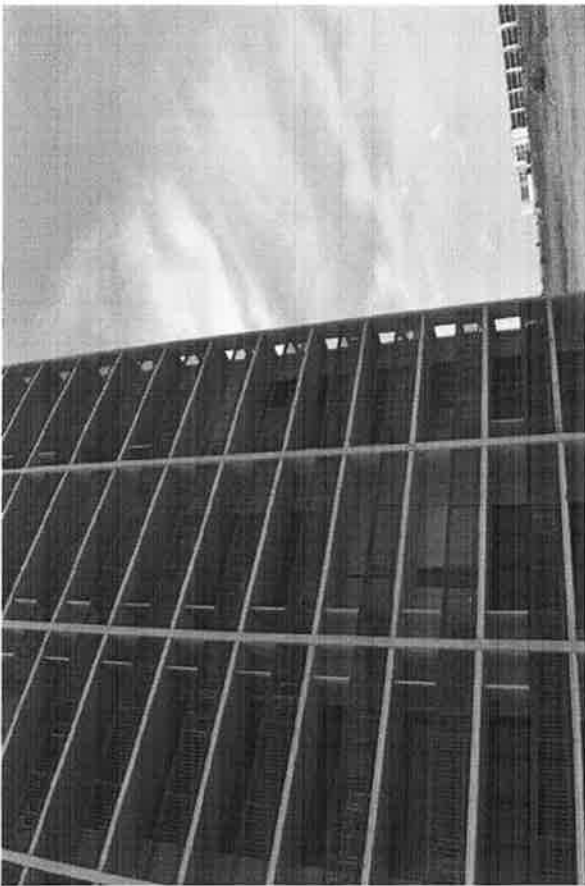
Photograph 4: East side of building (typical)

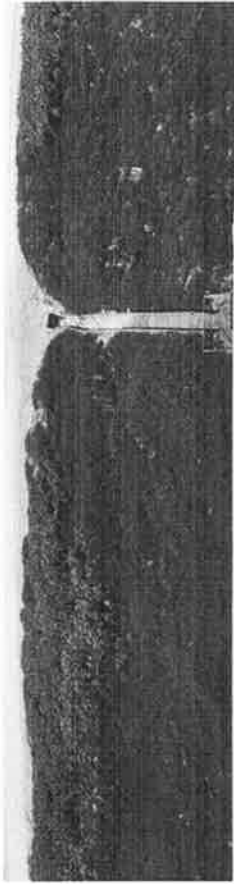
3. The mod-bit built-up roof revealed clear evidence of a long history of prior repair. These prior repairs include sealant applications along seams in the mod-bit cap sheet and base flashing and at flashing around plumbing vents.

Photograph 26: Sealant repair around seam in base flashing (typical)

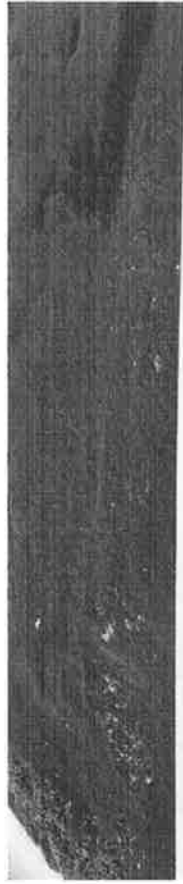
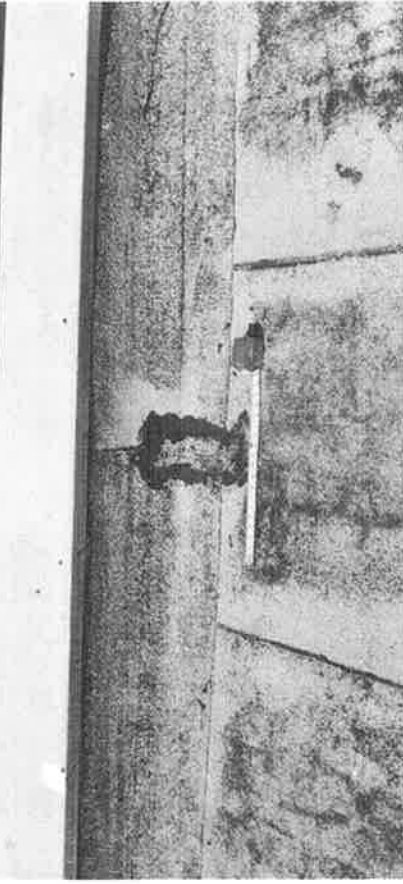
Photograph 27: Sealant repair around seam in base flashing (typical)

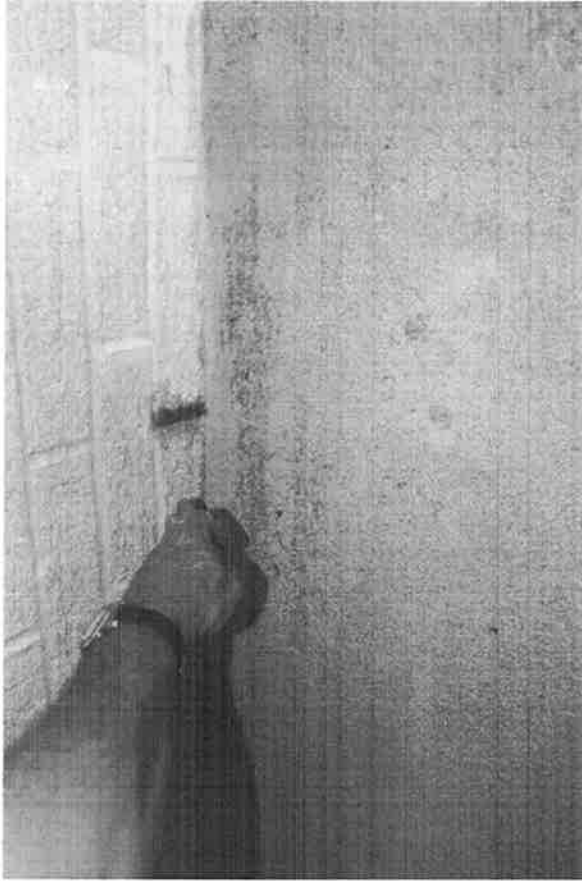
6. The concrete walkway located at the west side of the building was inadequately sloped to promote drainage of blowing rain water. As a result, this condominium building has experienced a history of water infiltration and associated damage along the weep holes in the brick veneer at the west side of the building. To eliminate water infiltration at the base of the brick veneer the weep holes had been sealed with a combination of both sealant and/or coating material on all floors of the building (ref. photographs 40-43).

Photograph 42: Close up view of sealant installed in weep holes in west side of building (typical)

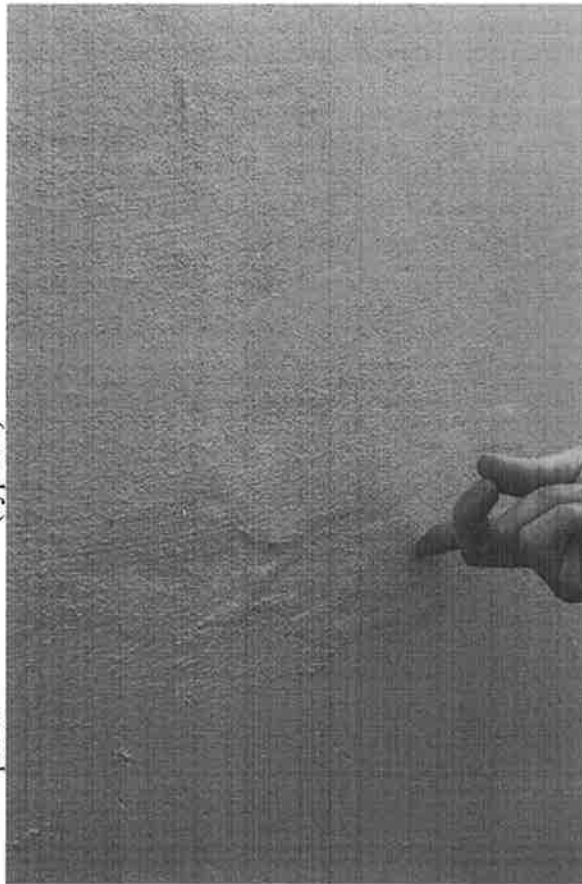
Photograph 56: Existing repair to exposed surface of hollow core concrete panel at room 1101 (typical)

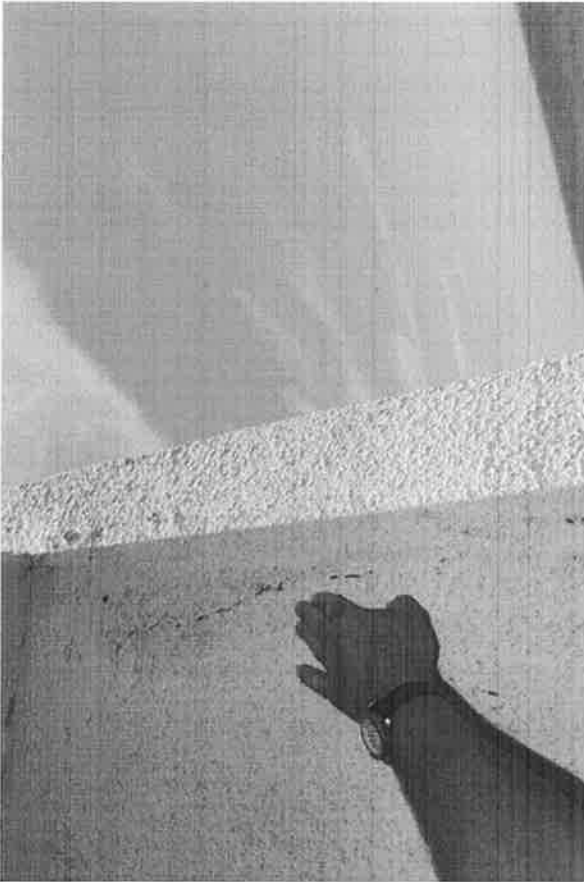
Inspection of this condominium building also revealed evidence of a long history of cracking and repair in the reinforced CMU walls supporting the hollow core concrete panels (ref. photographs 64-79). This cracking was most severe on the east side of the building, with direct exposure to the Gulf of Mexico. Many of the repaired cracks in the CMU walls exhibited evidence of additional distress (ref. photographs 64-67, 70, and 74). Other areas of distress in the building also exhibited evidence of prior repair (ref. photographs 66, 69, 71, 73, and 75). The ongoing cracking and related distress in the CMU walls is the result of long term exposure to the harsh coastal environment. The ongoing distress in the CMU walls is not related to Hurricane Harvey.

Photograph 64: Isolated crack along previously repaired area of CMU wall (typical)

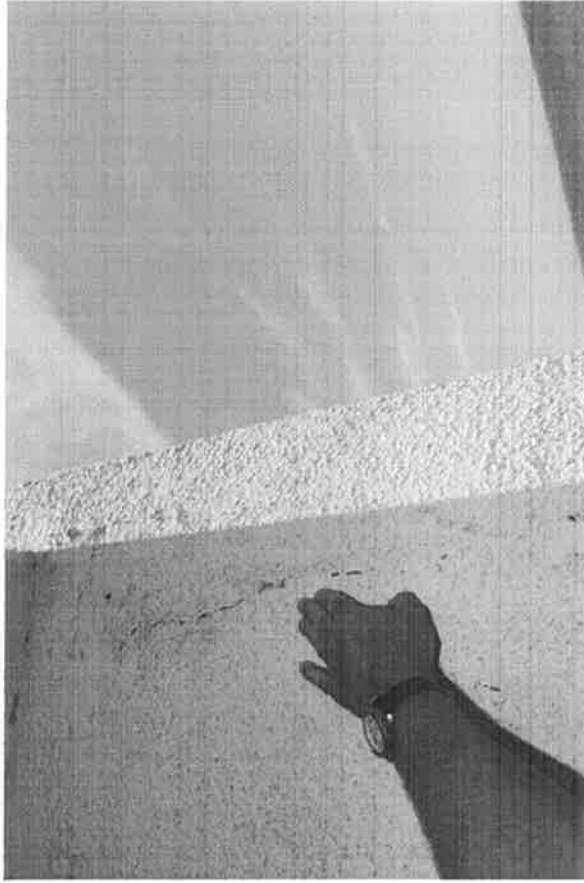
Photograph 70: Hairline crack in area of previously repaired CMU wall at unit 1101 (typical)
